Appendix A

Wetland Determination Forms and Site Photography

Project/Site: Sterling Highway Project MP 45 - 60	Date	8/11/03
Applicant / Owner: ADOT&PF	Borough	KPB
Investigators: JDS & MB	State	AK
Do Normal Circumstances exist on the site? <input checked="" type="checkbox"/> YES <input type="checkbox"/> NO	Community ID	Open black spruce bog
Is the site significantly disturbed (Atypical Situation)? <input type="checkbox"/> YES <input checked="" type="checkbox"/> NO	Transect ID	-
Is the area a potential Problem Area? (If needed, explain on reverse) <input type="checkbox"/> YES <input checked="" type="checkbox"/> NO	Plot ID	Plot 1

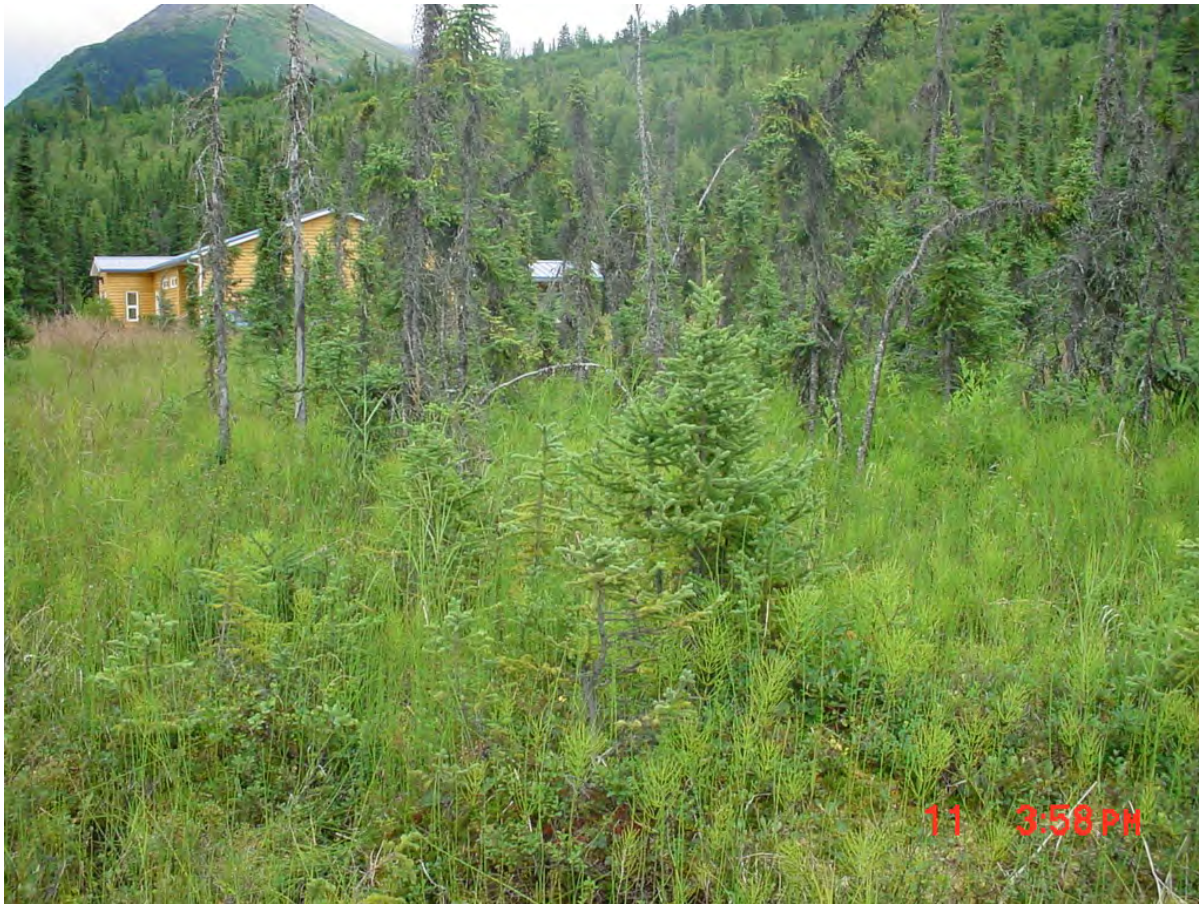
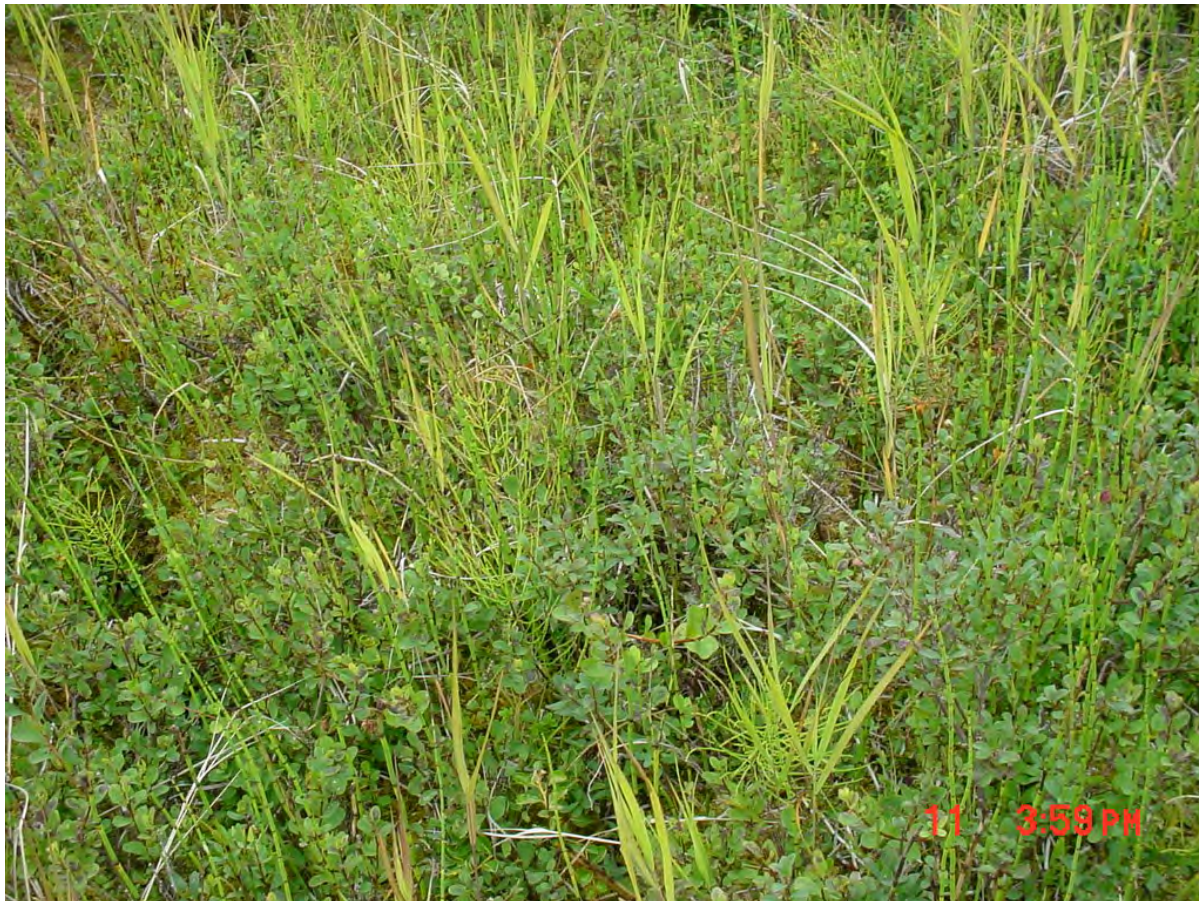
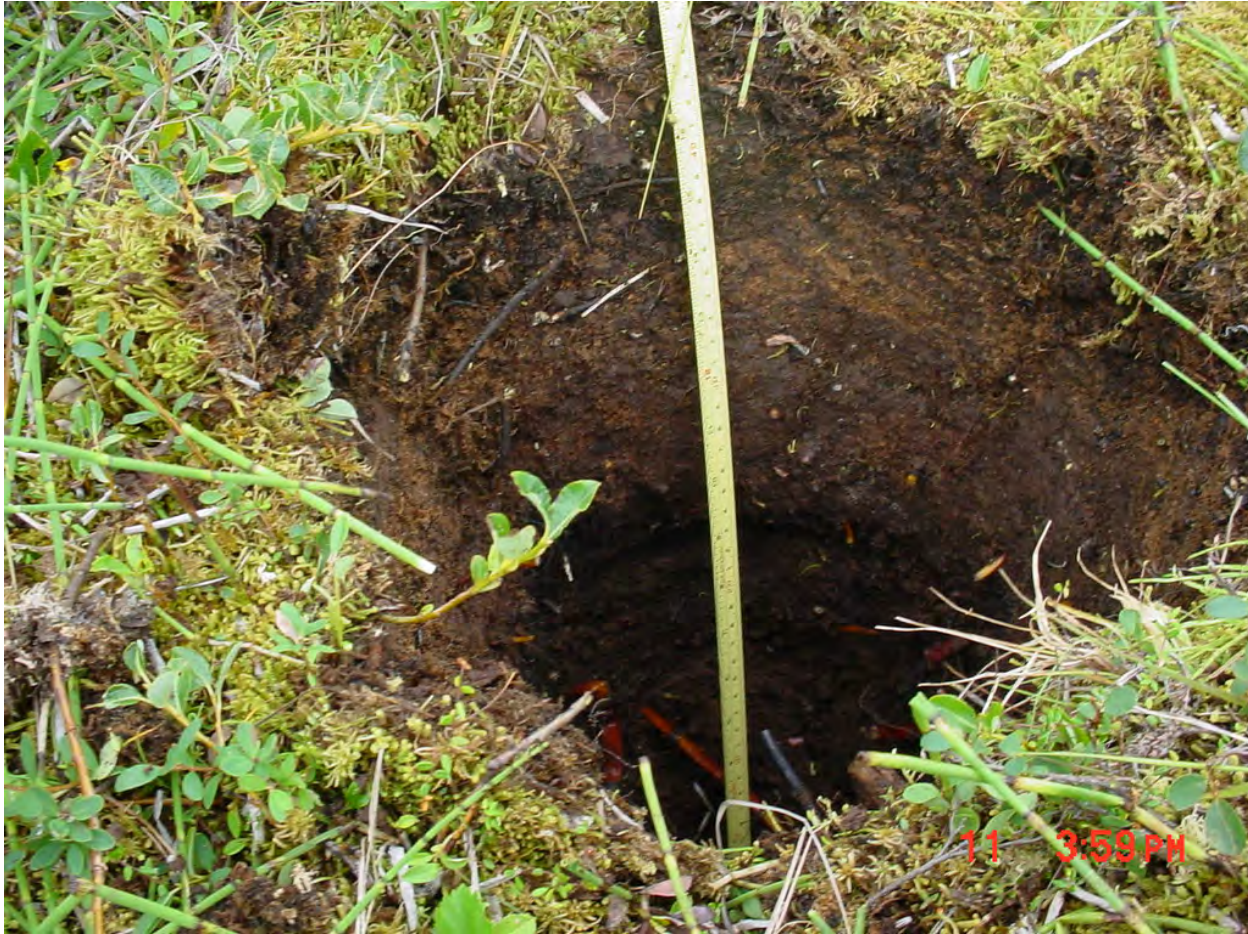
Site: Plot 1

Describe Vegetation Type: Open, shrubby black spruce bog.

Remarks: Area seems drier than normal.

Hydrophytic Vegetation Present?	<input checked="" type="checkbox"/> YES <input type="checkbox"/> NO	Is this Sampling Point Within a Wetland? <input checked="" type="checkbox"/> YES <input type="checkbox"/> NO
Wetland Hydrology Present?	<input checked="" type="checkbox"/> YES <input type="checkbox"/> NO	
Hydric Soils Present?	<input checked="" type="checkbox"/> YES <input type="checkbox"/> NO	
Remarks:		
GPS: Trimble plot 1 Topography: flat NWI Class: PSS1/EM1B HGM Type: flat Photos: yes (1-3) Functions: see function form

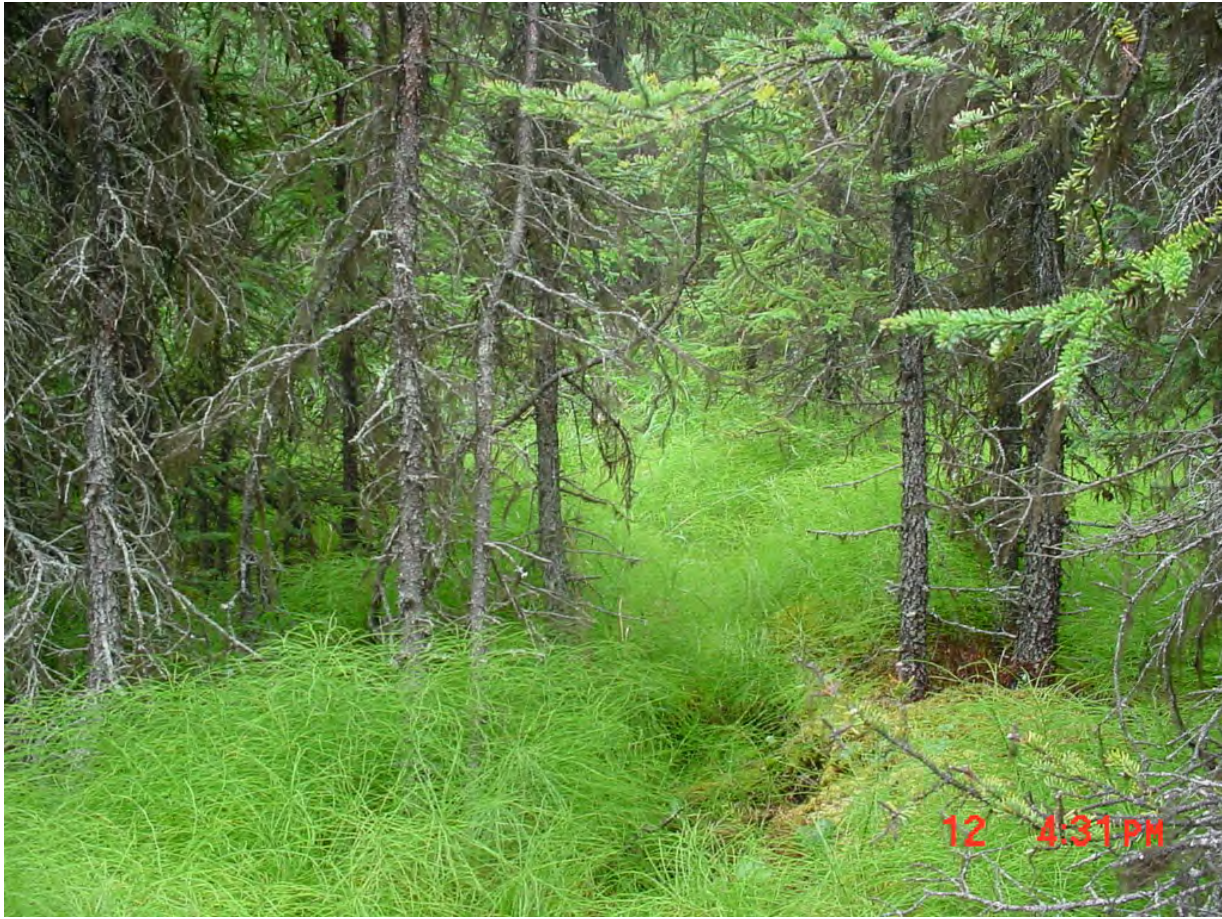
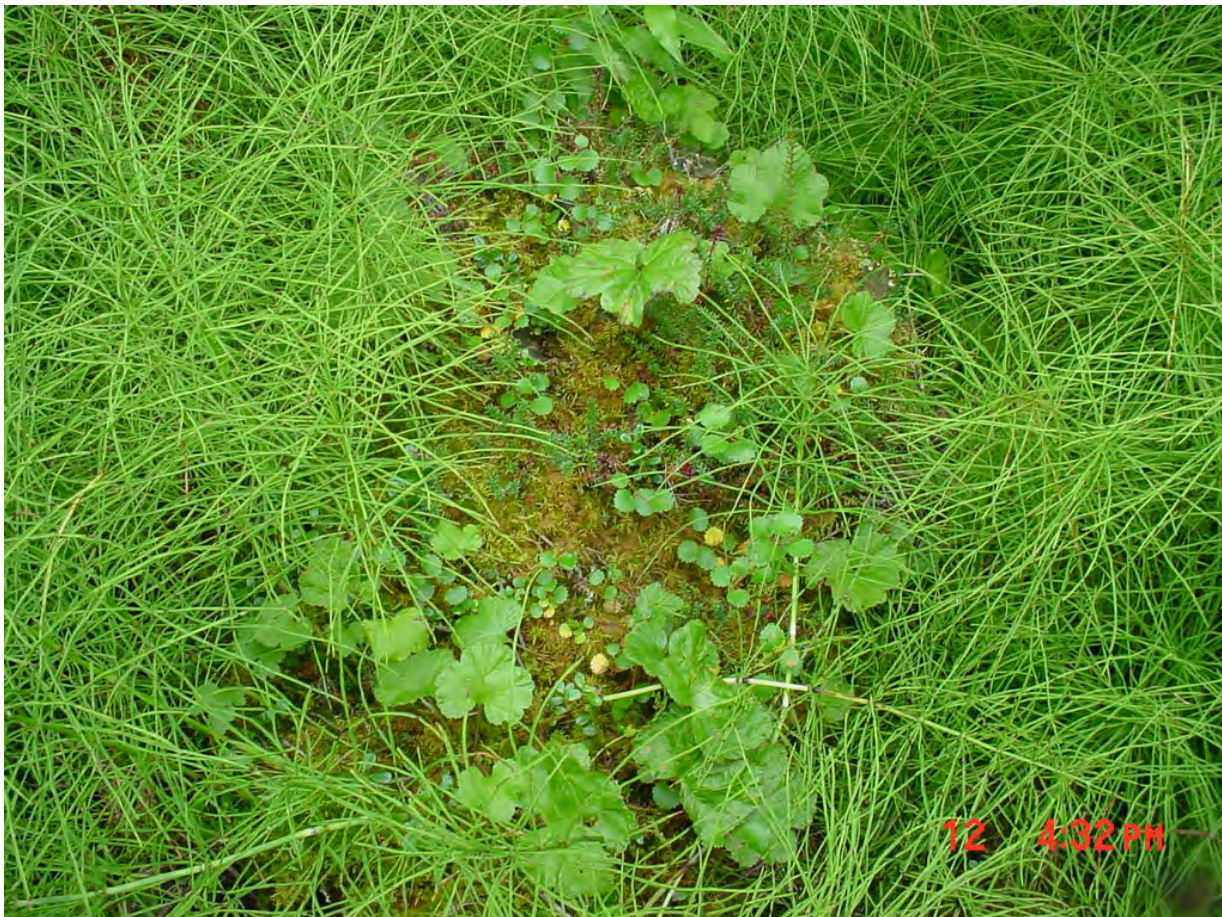
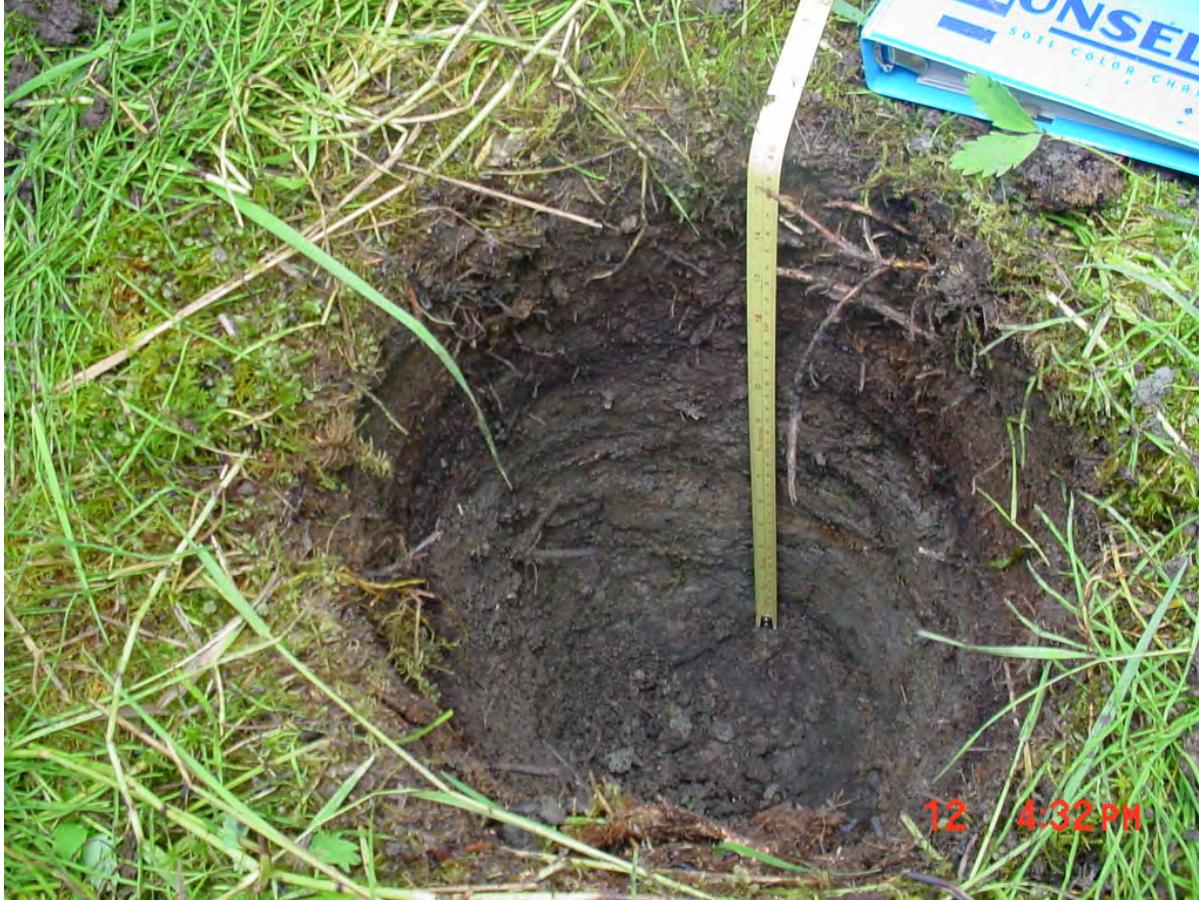
Site: Plot 2

Describe Vegetation Type: black spruce forest with horsetail understory. Adjacent areas have more black spruce.

Hydrophytic Vegetation Present?	<input checked="" type="checkbox"/> YES <input type="checkbox"/> NO	Is this Sampling Point Within a Wetland? <input checked="" type="checkbox"/> YES <input type="checkbox"/> NO
Wetland Hydrology Present?	<input checked="" type="checkbox"/> YES <input type="checkbox"/> NO	
Hydric Soils Present?	<input checked="" type="checkbox"/> YES <input type="checkbox"/> NO	
Remarks:		
GPS: Trimble plot 2 Topography: hummocky NWI Class: PFO4/EM2B HGM Type: flat Photos: yes Functions: see function form

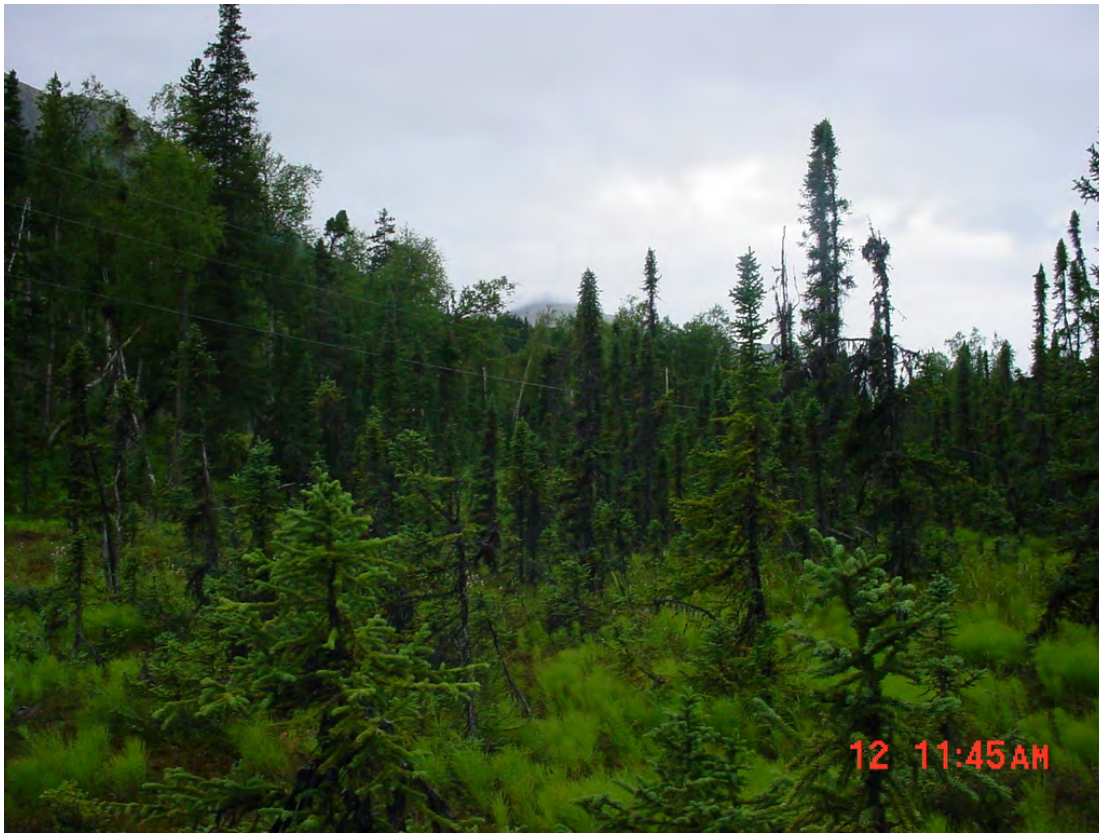
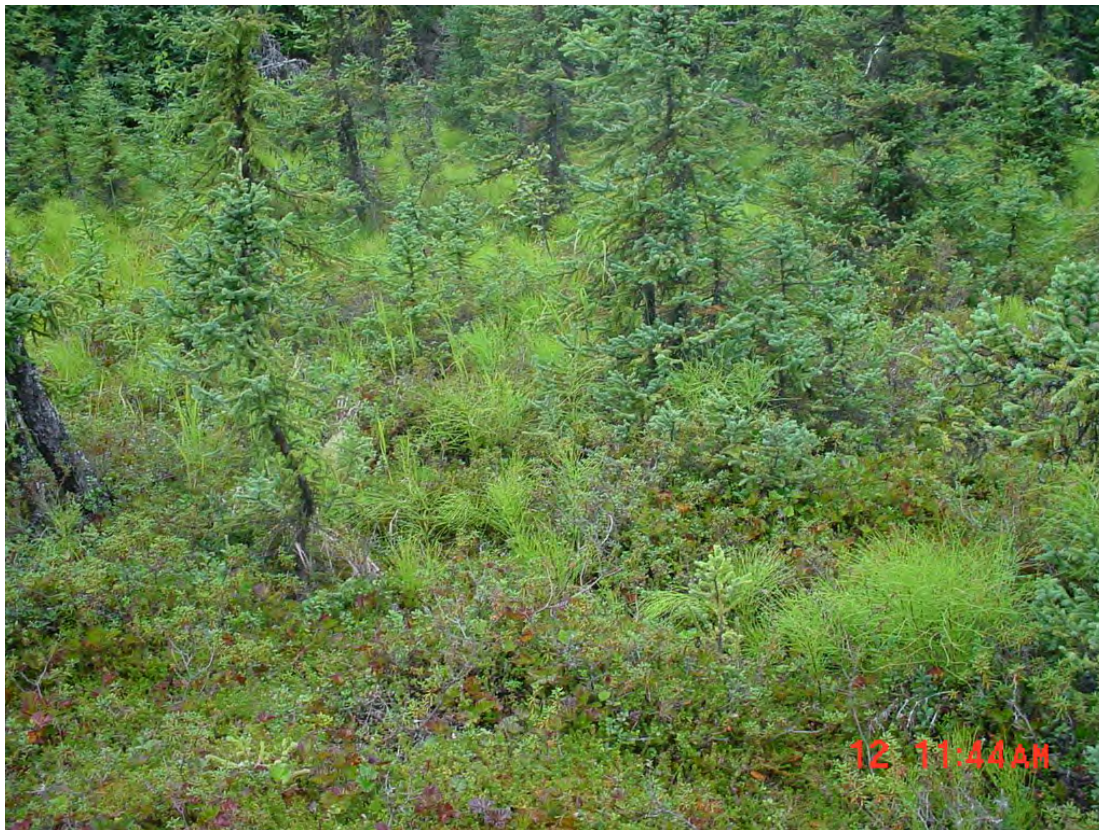
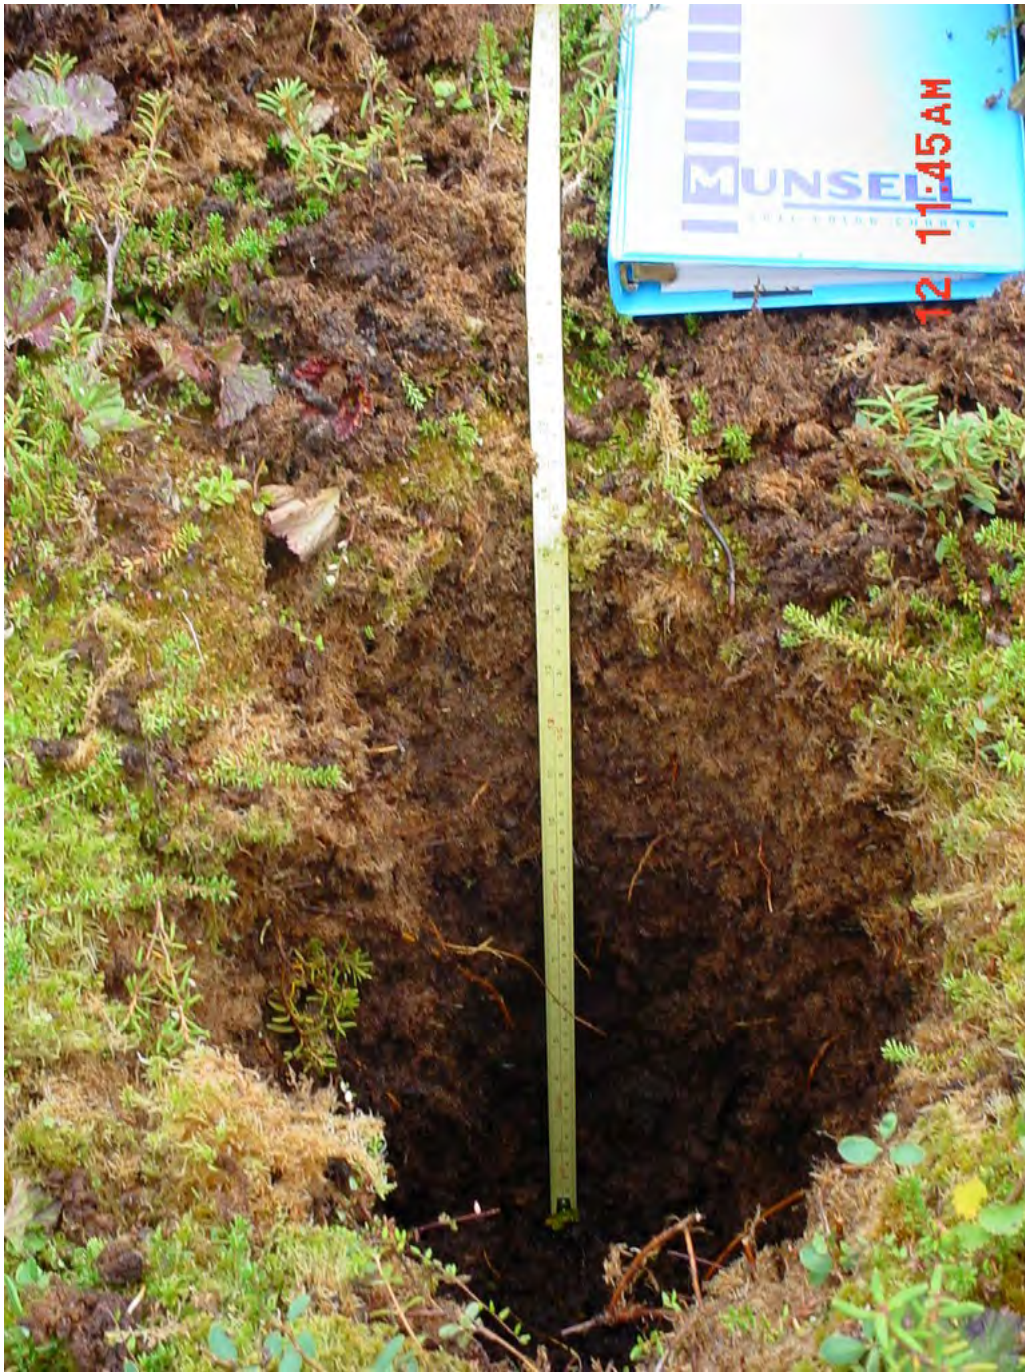
Describe Vegetation Type: Black spruce bog

Hydrophytic Vegetation Present?	<input checked="" type="checkbox"/> YES <input type="checkbox"/> NO	Is this Sampling Point Within a Wetland? <input checked="" type="checkbox"/> YES <input type="checkbox"/> NO
Wetland Hydrology Present?	<input checked="" type="checkbox"/> YES <input type="checkbox"/> NO	
Hydric Soils Present?	<input checked="" type="checkbox"/> YES <input type="checkbox"/> NO	
Remarks:		
GPS: Trimble plot 3 Topography: slightly hummocky NWI Class: PSS1/4B HGM Type: flat Photos: yes Functions: see function form

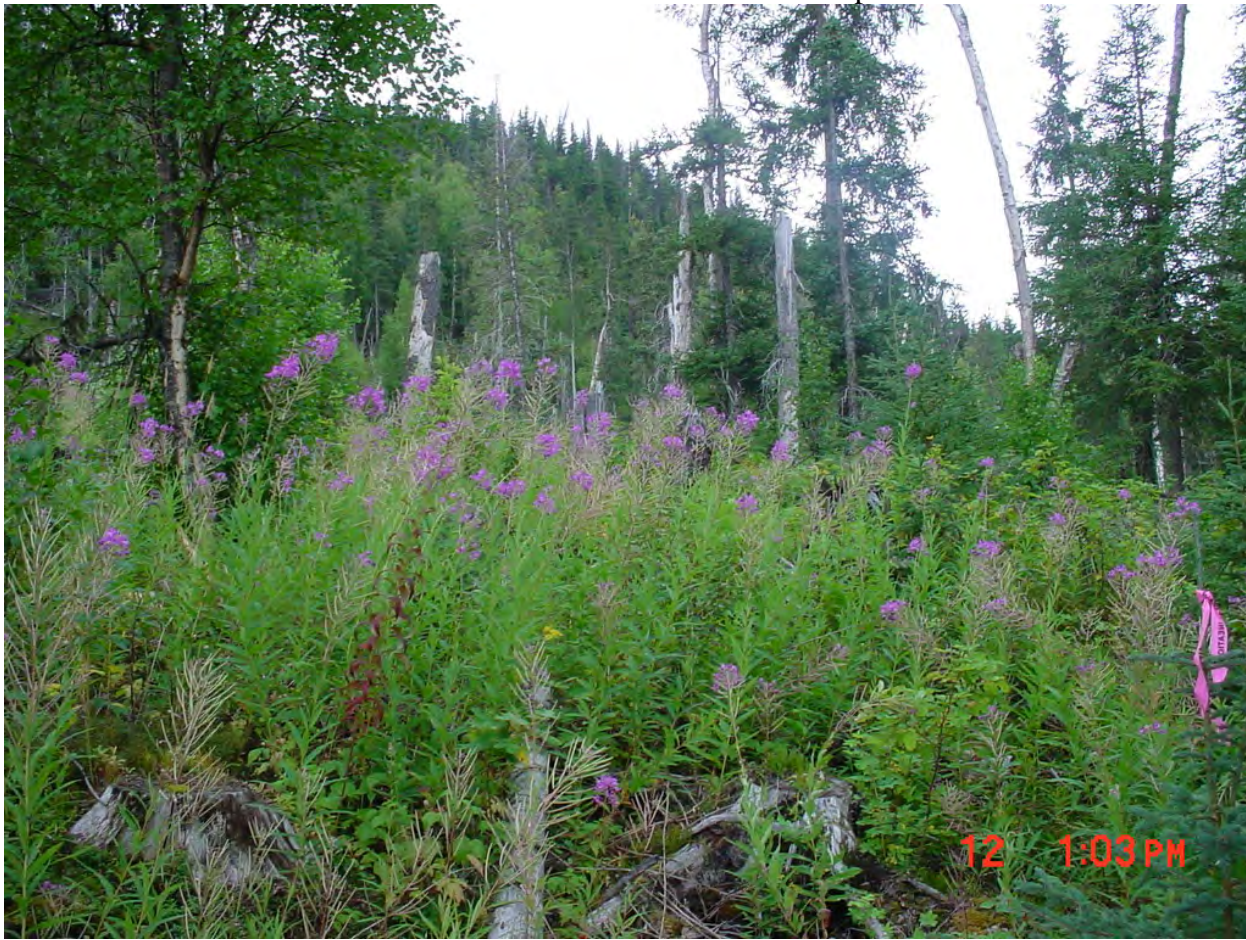
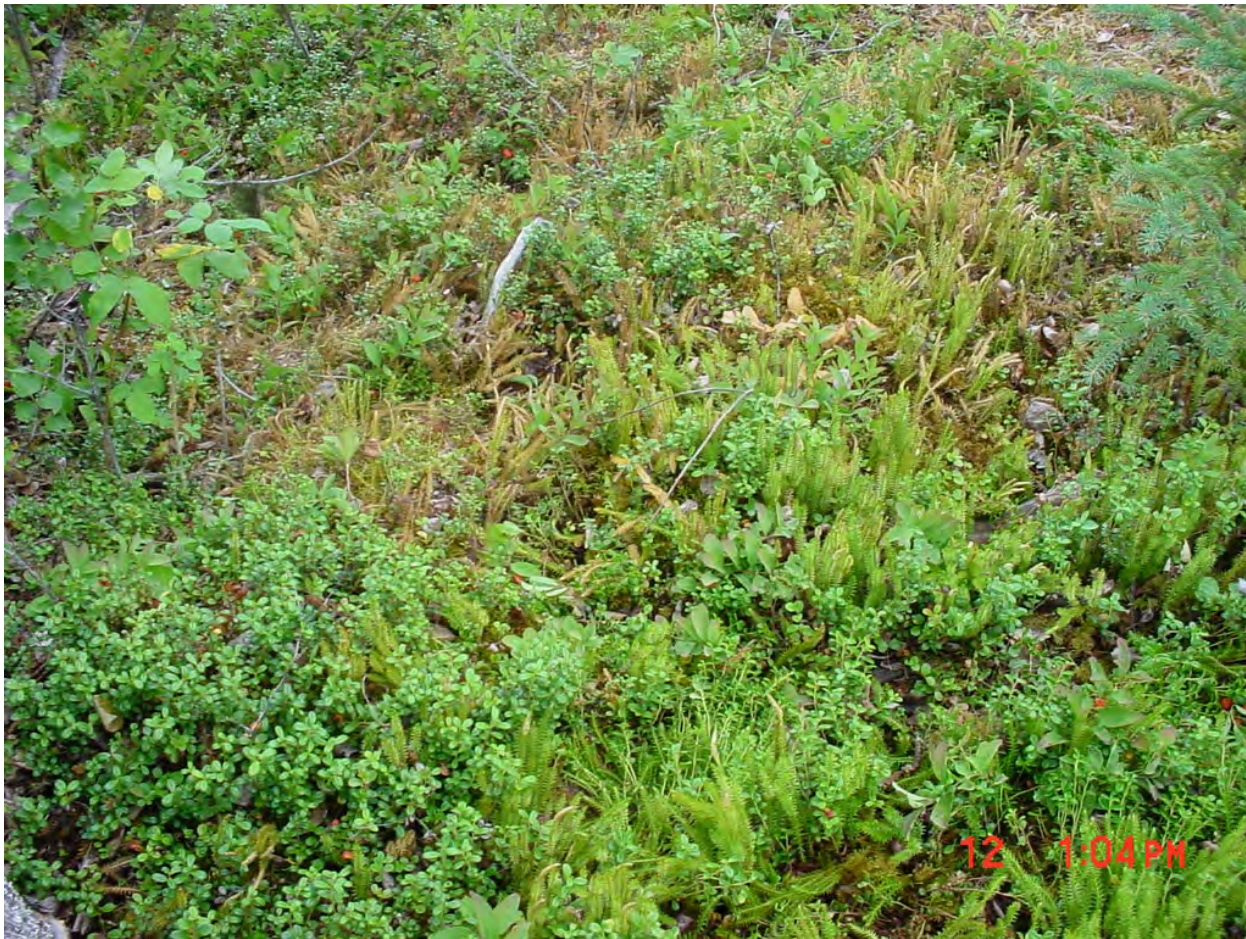
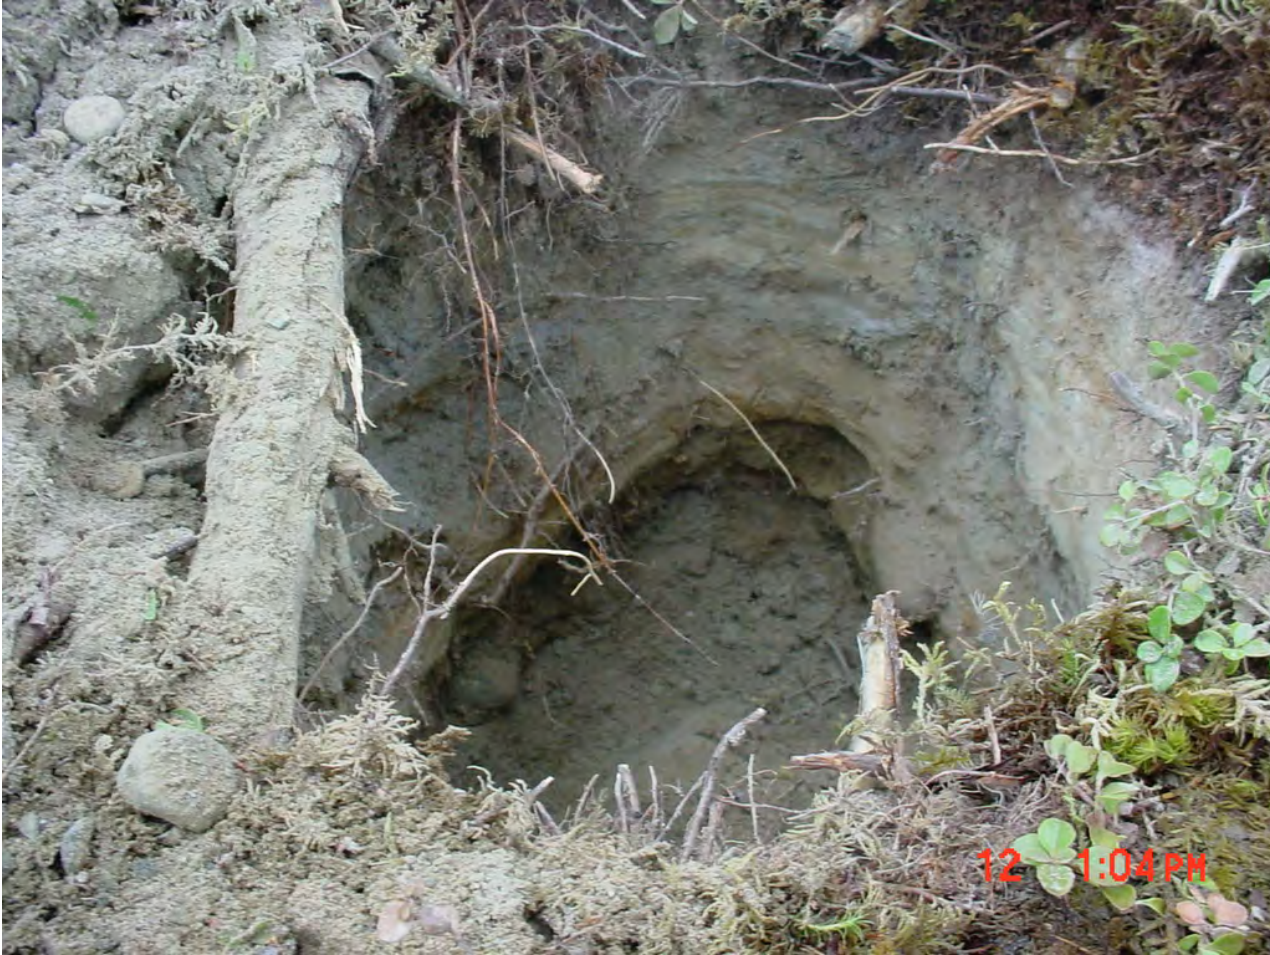
Site: Plot 4

Describe Vegetation Type: open paper birch, lutz spruce forest

Hydrophytic Vegetation Present?	<input type="checkbox"/> YES <input checked="" type="checkbox"/> NO	Is this Sampling Point Within a Wetland? <input type="checkbox"/> YES <input checked="" type="checkbox"/> NO
Wetland Hydrology Present?	<input type="checkbox"/> YES <input checked="" type="checkbox"/> NO	
Hydric Soils Present?	<input type="checkbox"/> YES <input checked="" type="checkbox"/> NO	
Remarks:		
Bald eagle, and evidence of moose browse		
GPS: Trimble plot 4		
Topography:		
NWI Class: U		
HGM Type: U		
Photos: yes		
Functions: wildlife habitat

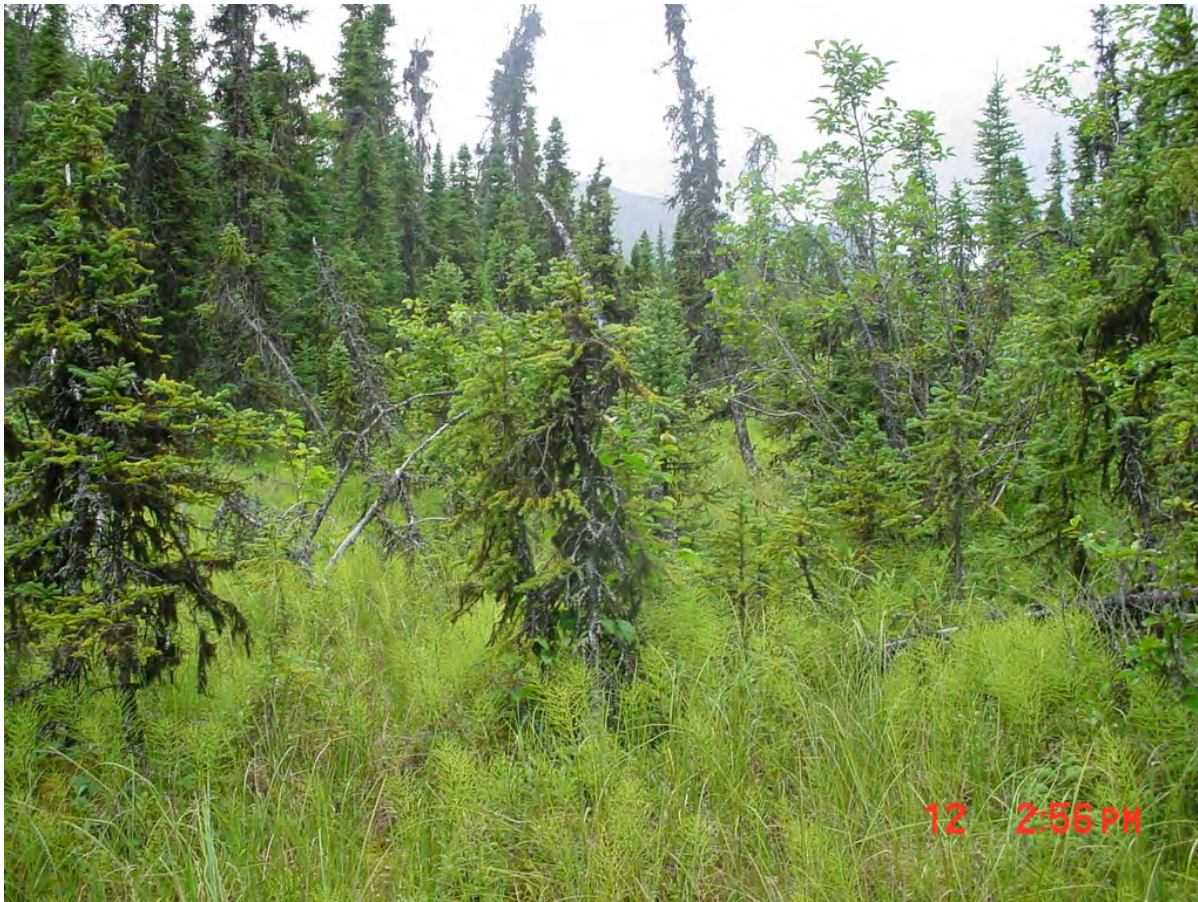
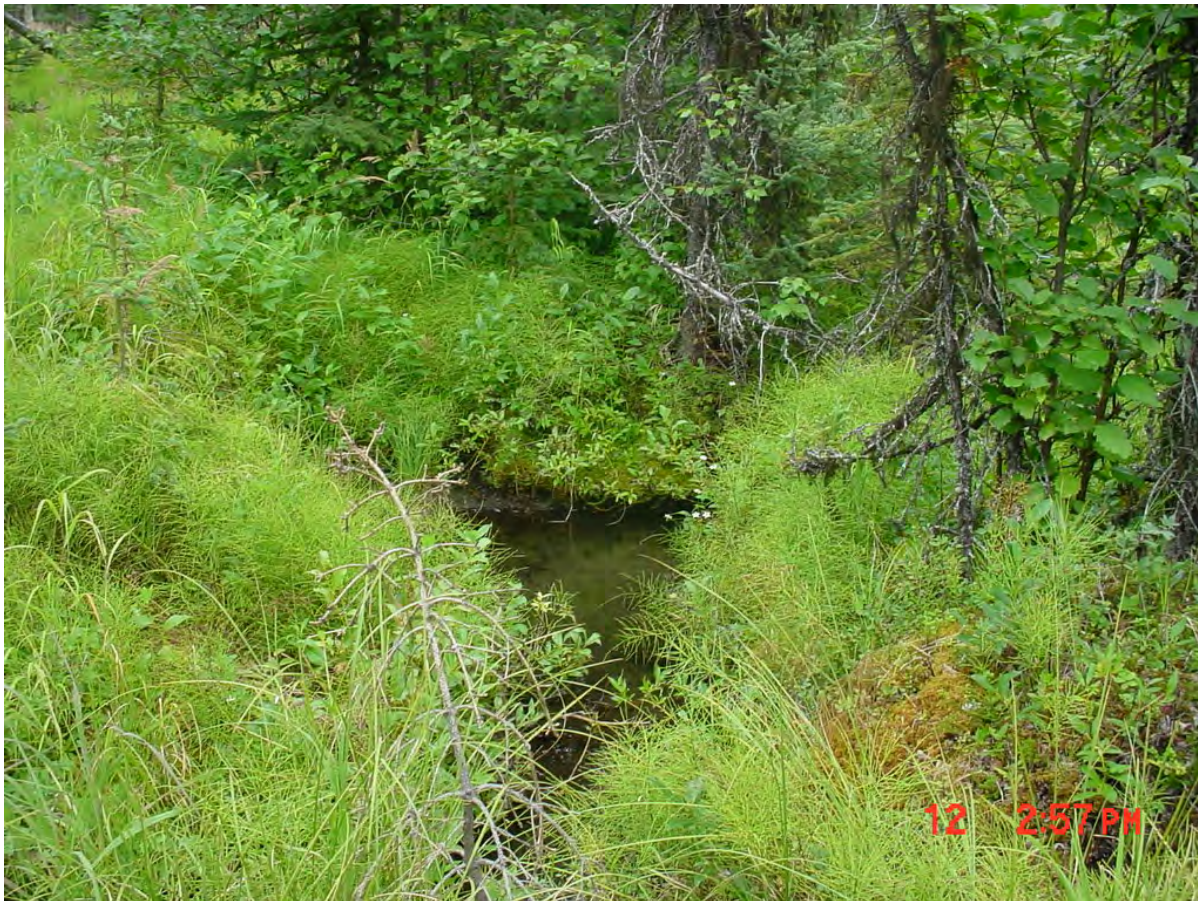
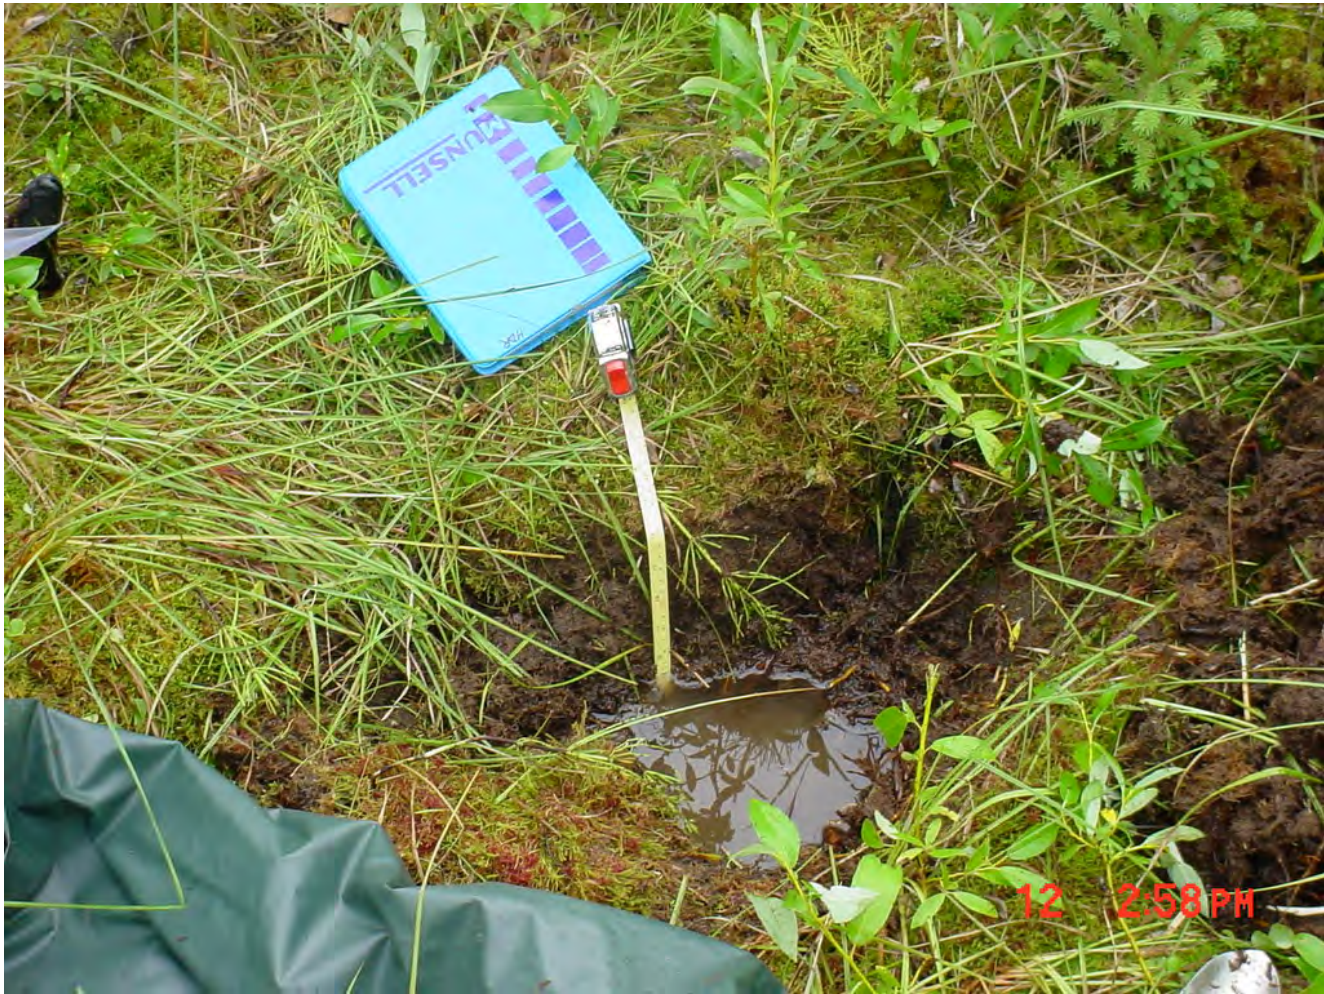
Site: Plot 5

Describe Vegetation Type: shrubby black spruce and equisetum.

Hydrophytic Vegetation Present?	<input checked="" type="checkbox"/> YES <input type="checkbox"/> NO	Is this Sampling Point Within a Wetland? <input checked="" type="checkbox"/> YES <input type="checkbox"/> NO
Wetland Hydrology Present?	<input checked="" type="checkbox"/> YES <input type="checkbox"/> NO	
Hydric Soils Present?	<input checked="" type="checkbox"/> YES <input type="checkbox"/> NO	
Remarks:		
GPS: Trimble plot 5 Topography: hummocky NWI Class: PSS4/EM2B HGM Type: flat/riverine (Kenai River) Photos: yes Functions: see form

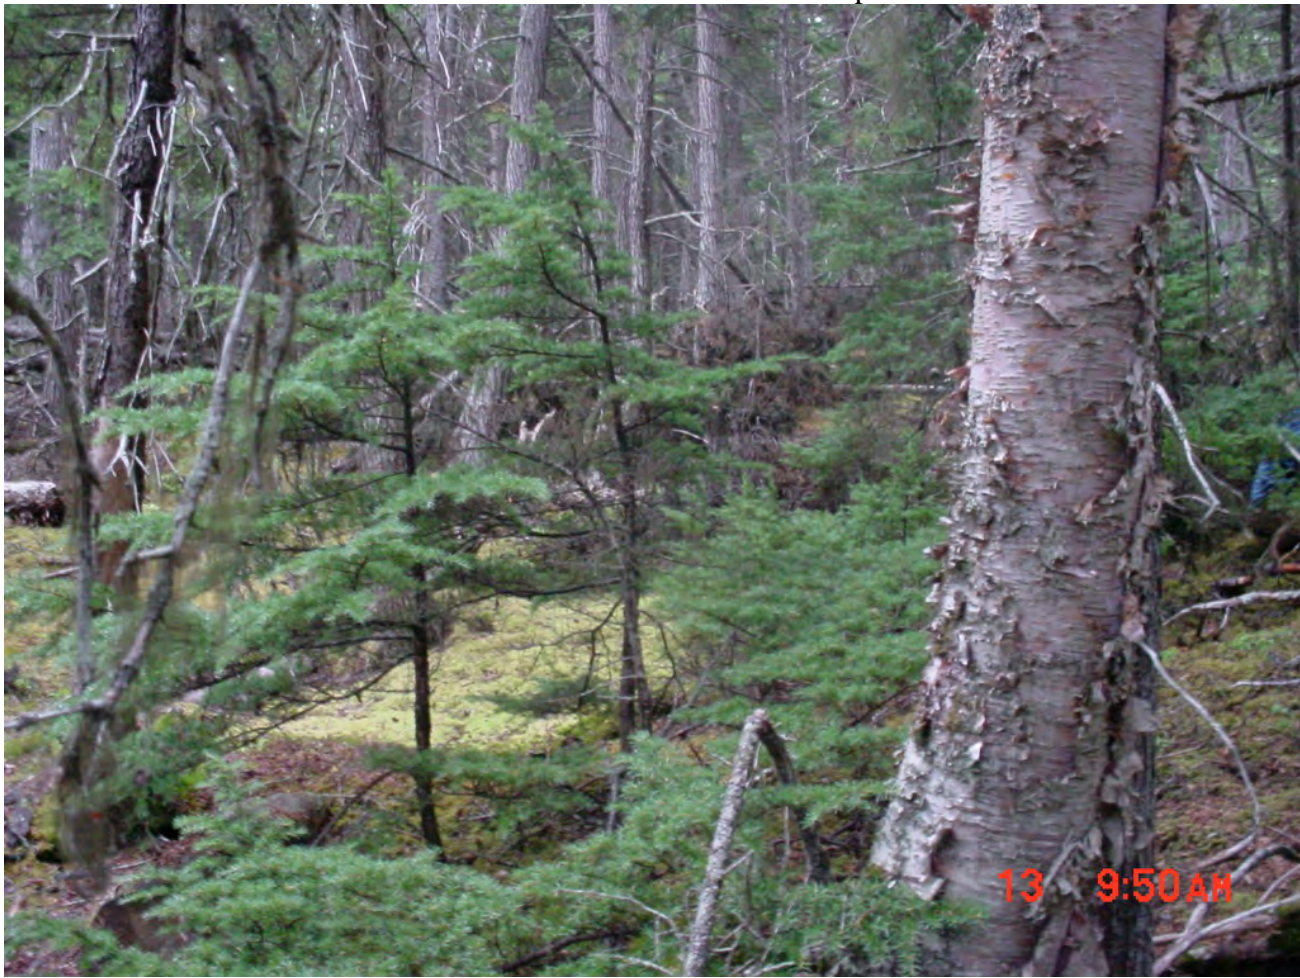
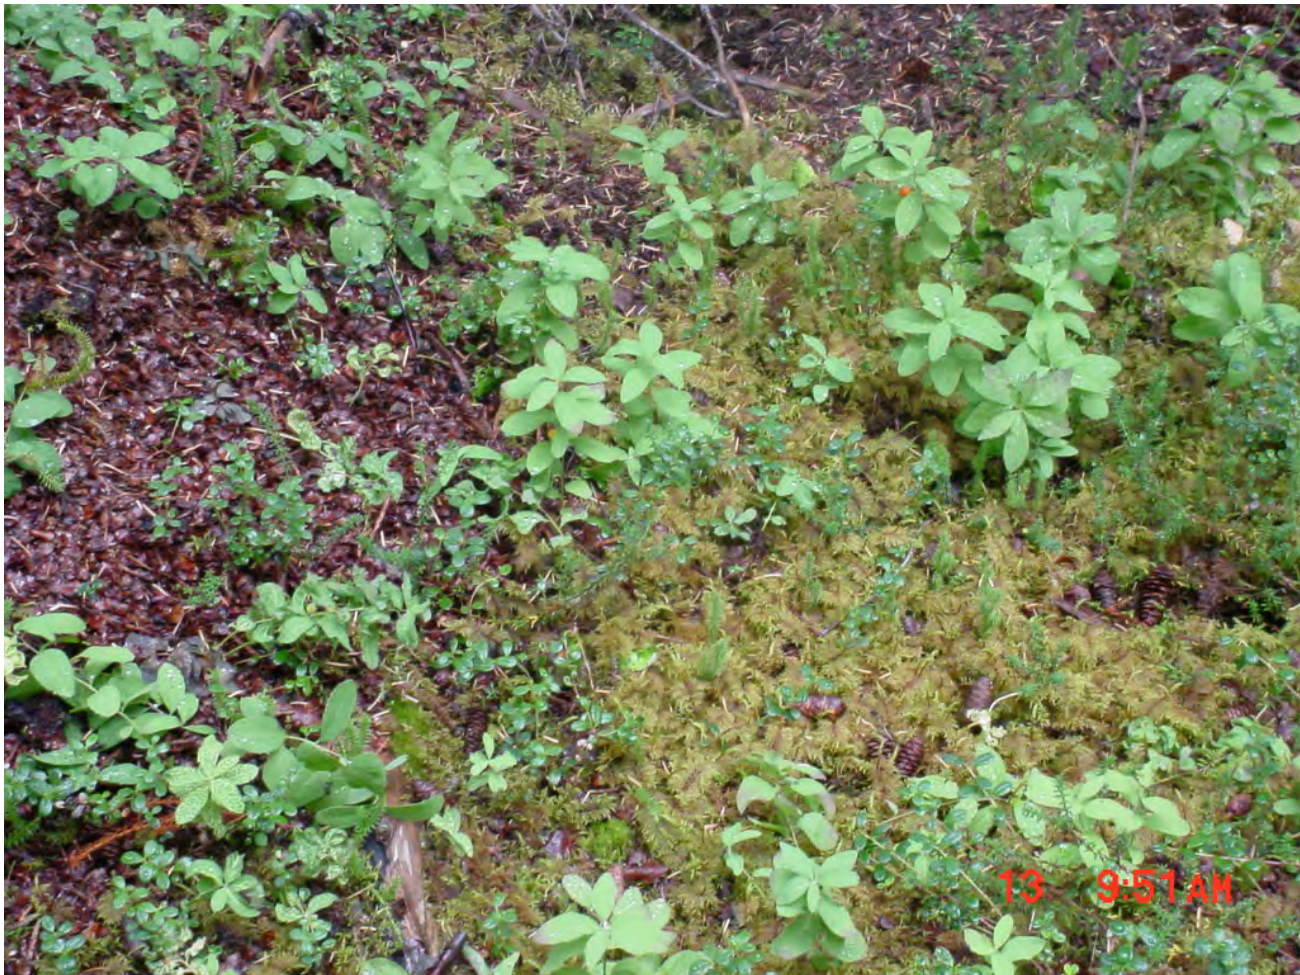
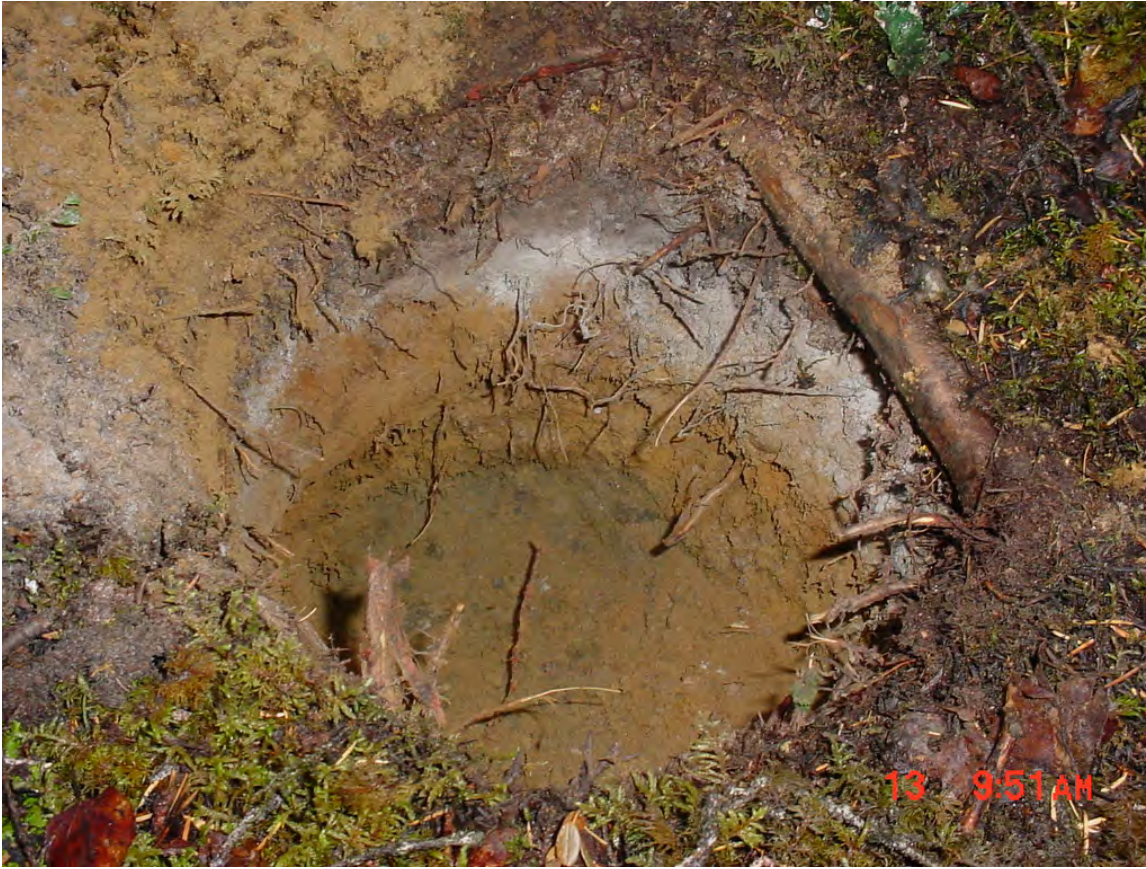
Site: Plot 6

Describe Vegetation Type: hemlock forest

Hydrophytic Vegetation Present?	<input checked="" type="checkbox"/> YES <input type="checkbox"/> NO	Is this Sampling Point Within a Wetland? <input type="checkbox"/> YES <input checked="" type="checkbox"/> NO
Wetland Hydrology Present?	<input type="checkbox"/> YES <input checked="" type="checkbox"/> NO	
Hydric Soils Present?	<input type="checkbox"/> YES <input checked="" type="checkbox"/> NO	
Remarks:		
GPS: Trimble plot 6 Topography: slope NWI Class: U HGM Type: U Photos: yes Functions:
