Appendix A

Wetland Determination Forms and Site Photography

Project/Site: Sterling Highway Project MP 45 - 60	Date	8/11/03
Applicant / Owner: ADOT&PF	Borough	KPB
Investigators: JDS & MB	State	AK
Do Normal Circumstances exist on the site? <input checked="" type="checkbox"/> YES <input type="checkbox"/> NO	Community ID	Open black spruce bog
Is the site significantly disturbed (Atypical Situation)? <input type="checkbox"/> YES <input checked="" type="checkbox"/> NO	Transect ID	-
Is the area a potential Problem Area? (If needed, explain on reverse) <input type="checkbox"/> YES <input checked="" type="checkbox"/> NO	Plot ID	Plot 1

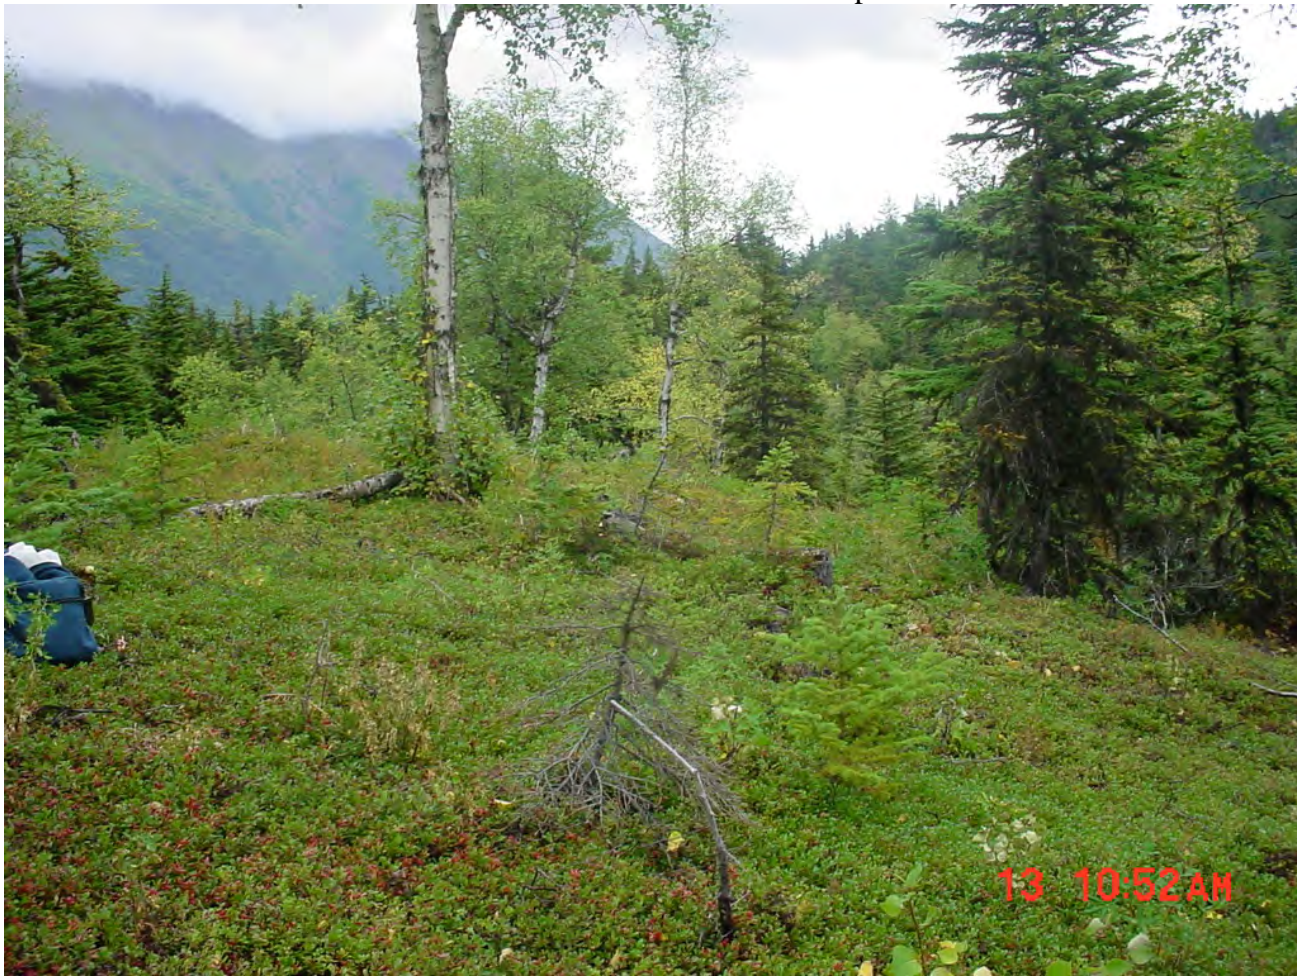
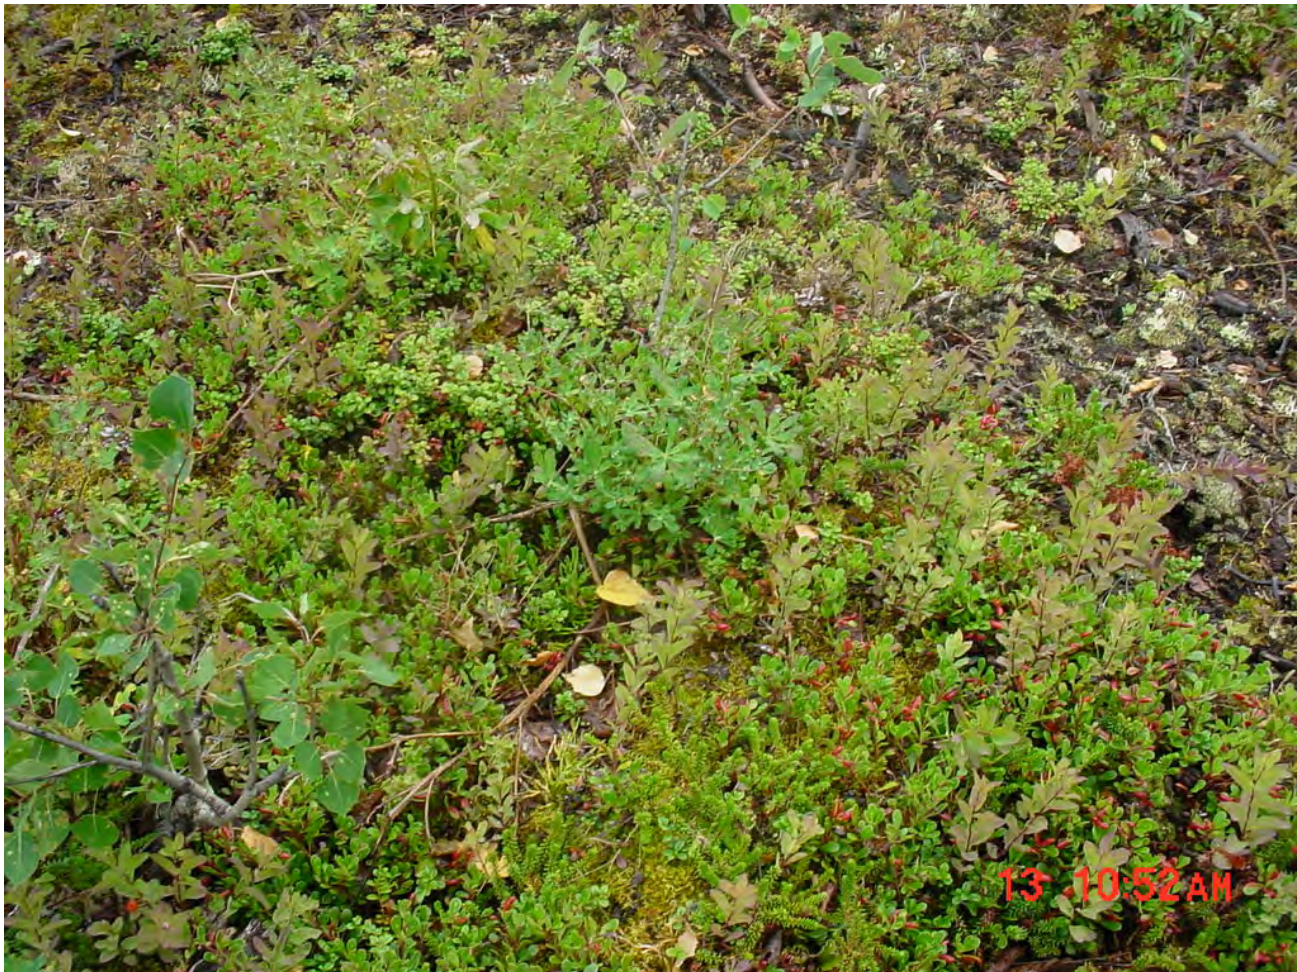
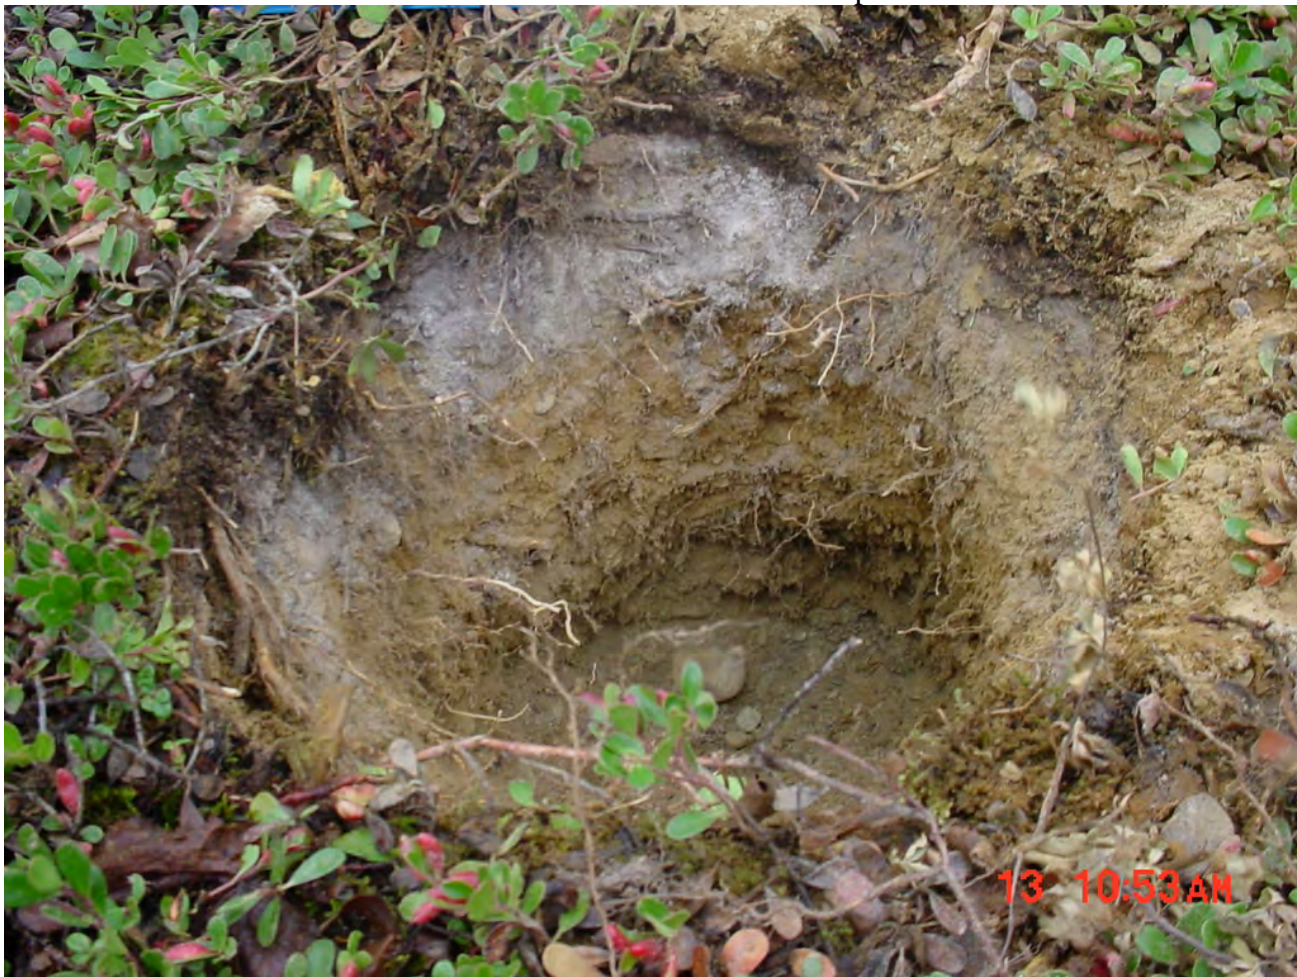
Site: Plot 7

Describe Vegetation Type: Open paper birch forest

Hydrophytic Vegetation Present?	<input type="checkbox"/> YES <input checked="" type="checkbox"/> NO (50 %)	Is this Sampling Point Within a Wetland? <input type="checkbox"/> YES <input checked="" type="checkbox"/> NO
Wetland Hydrology Present?	<input type="checkbox"/> YES <input checked="" type="checkbox"/> NO	
Hydric Soils Present?	<input type="checkbox"/> YES <input checked="" type="checkbox"/> NO	
Remarks:		
GPS: Trimble plot 7 Topography: top of slope NWI Class: U HGM Type: U Photos: yes Functions:

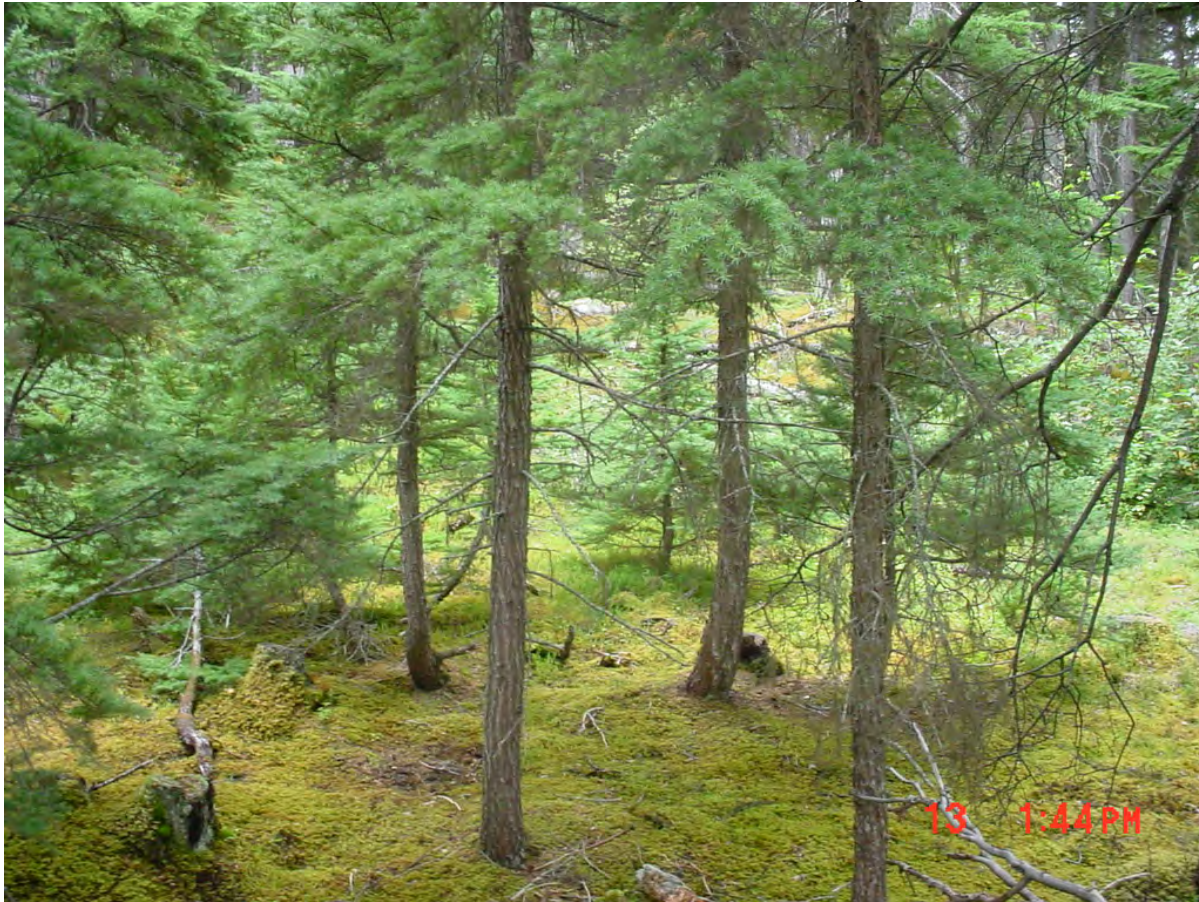
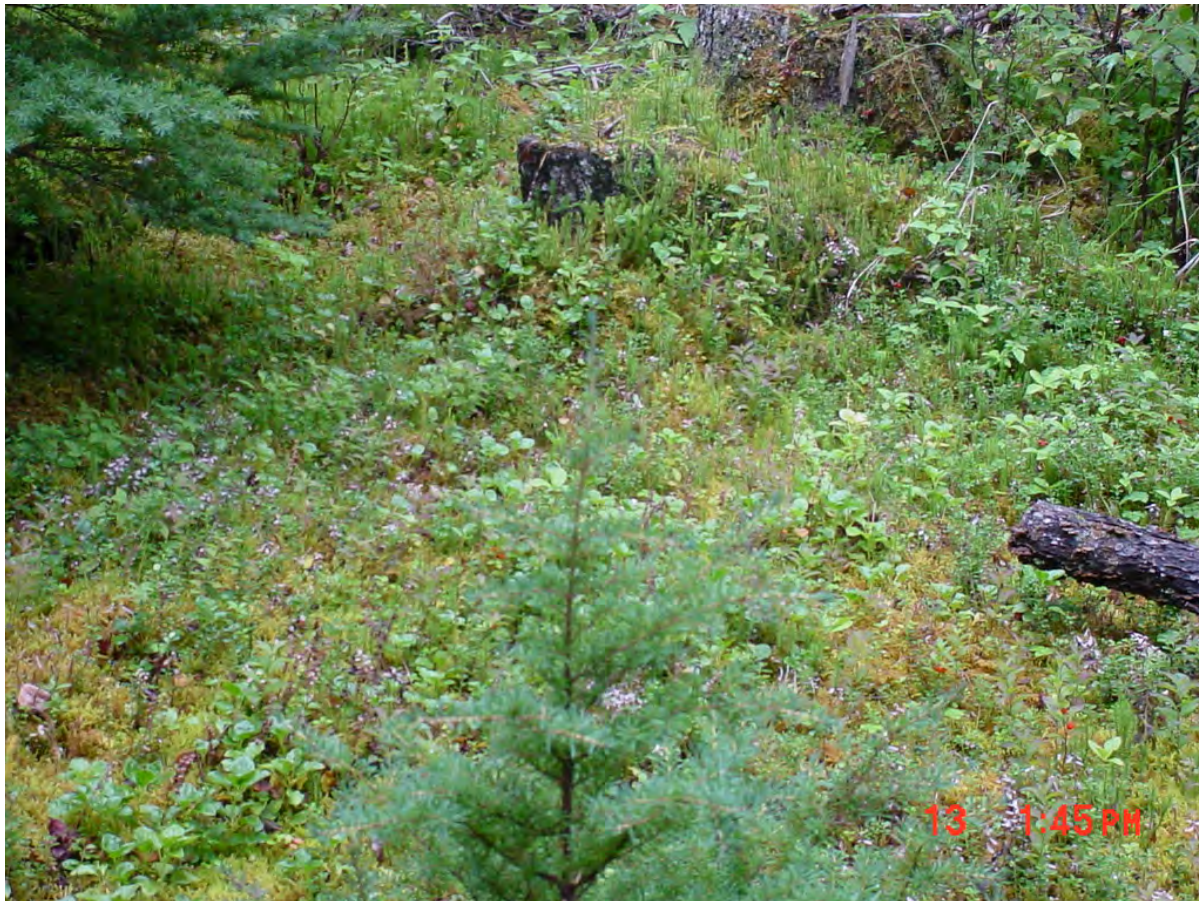
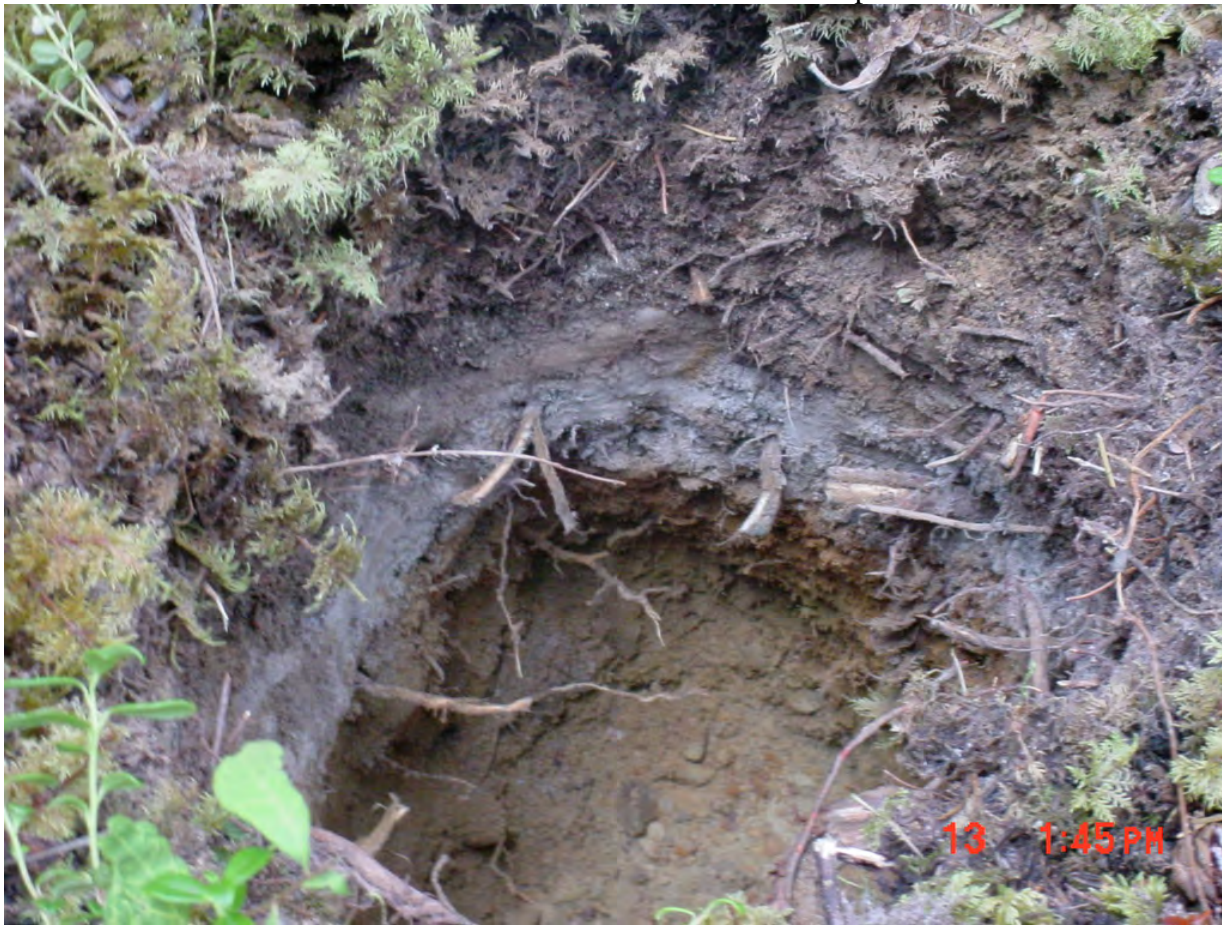
Site: Plot 8

Describe Vegetation Type: hemlock forest

Hydrophytic Vegetation Present?	<input checked="" type="checkbox"/> YES <input type="checkbox"/> NO	Is this Sampling Point Within a Wetland? <input type="checkbox"/> YES <input checked="" type="checkbox"/> NO
Wetland Hydrology Present?	<input type="checkbox"/> YES <input checked="" type="checkbox"/> NO	
Hydric Soils Present?	<input type="checkbox"/> YES <input checked="" type="checkbox"/> NO	
Remarks:		
GPS: Trimble plot 8 Topography: slight slope NWI Class: U HGM Type: U Photos: yes Functions: Aspect: 4 degrees

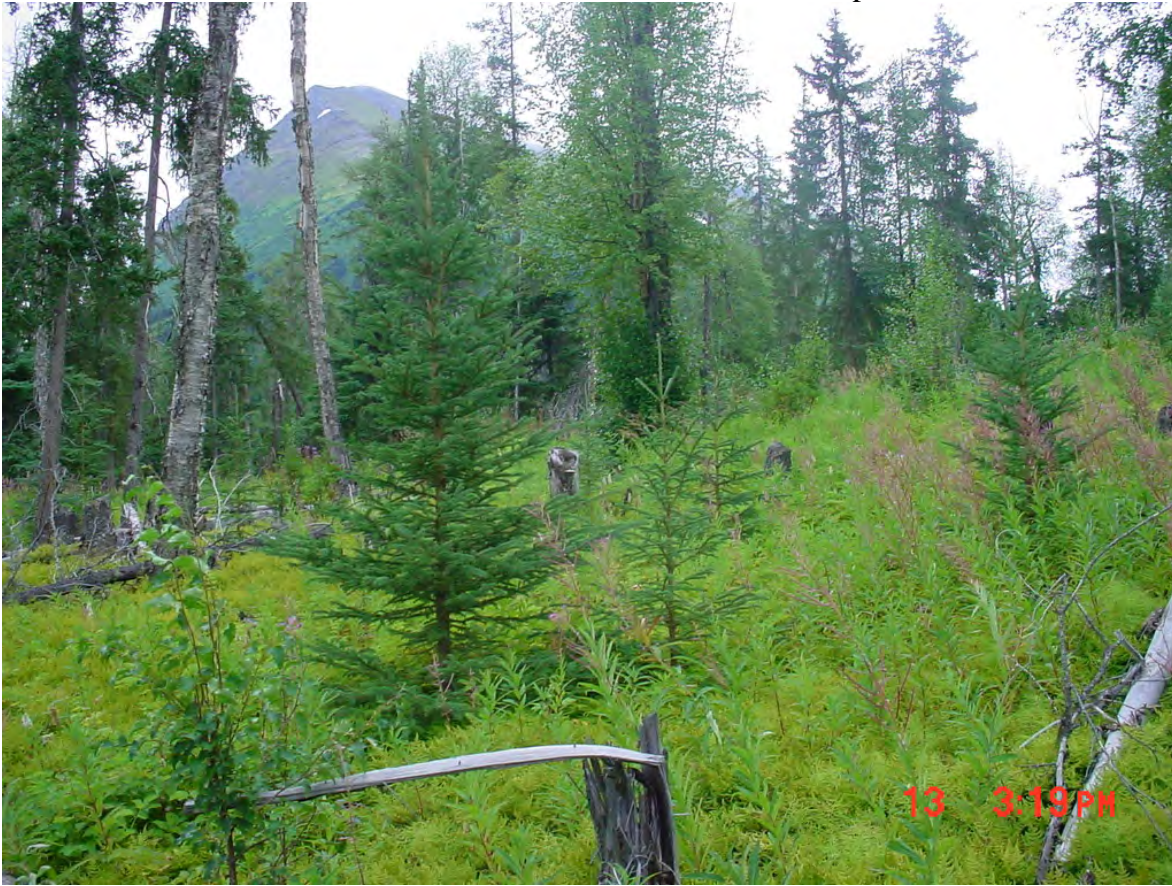
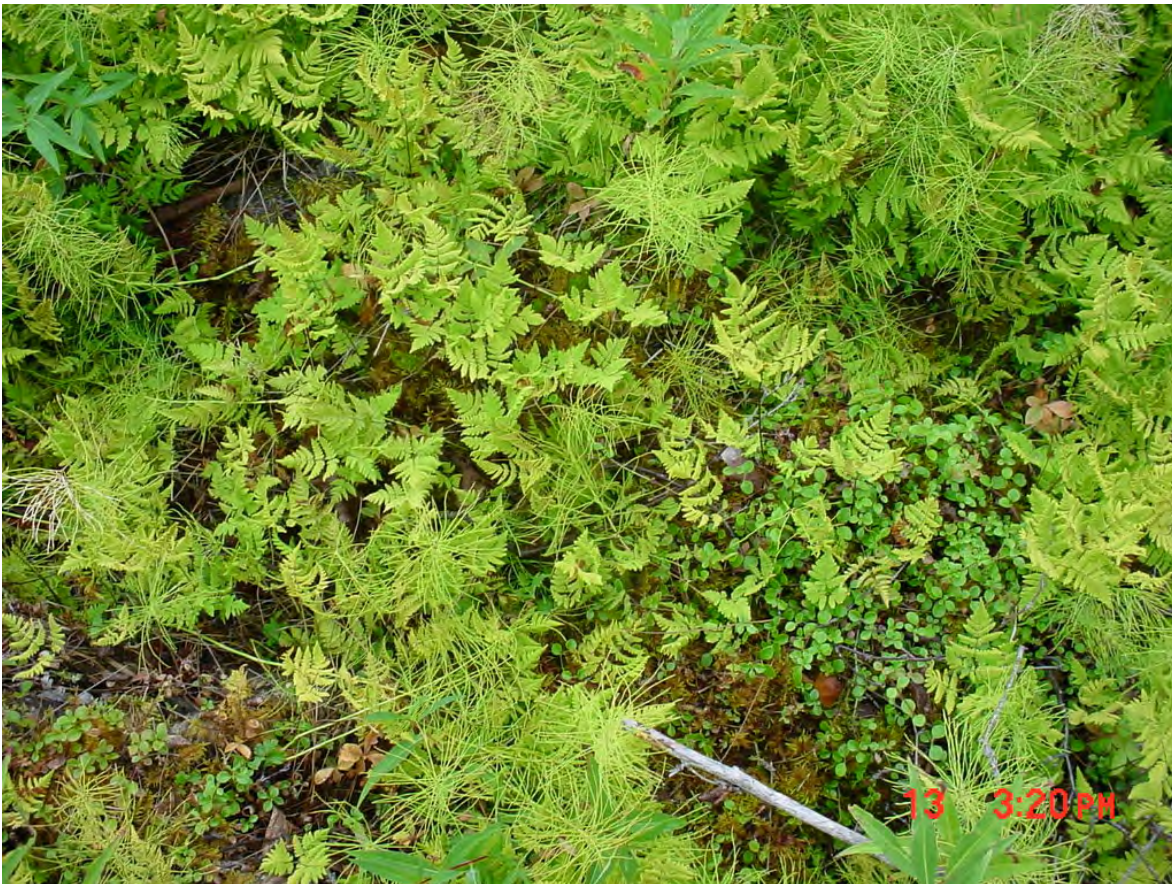
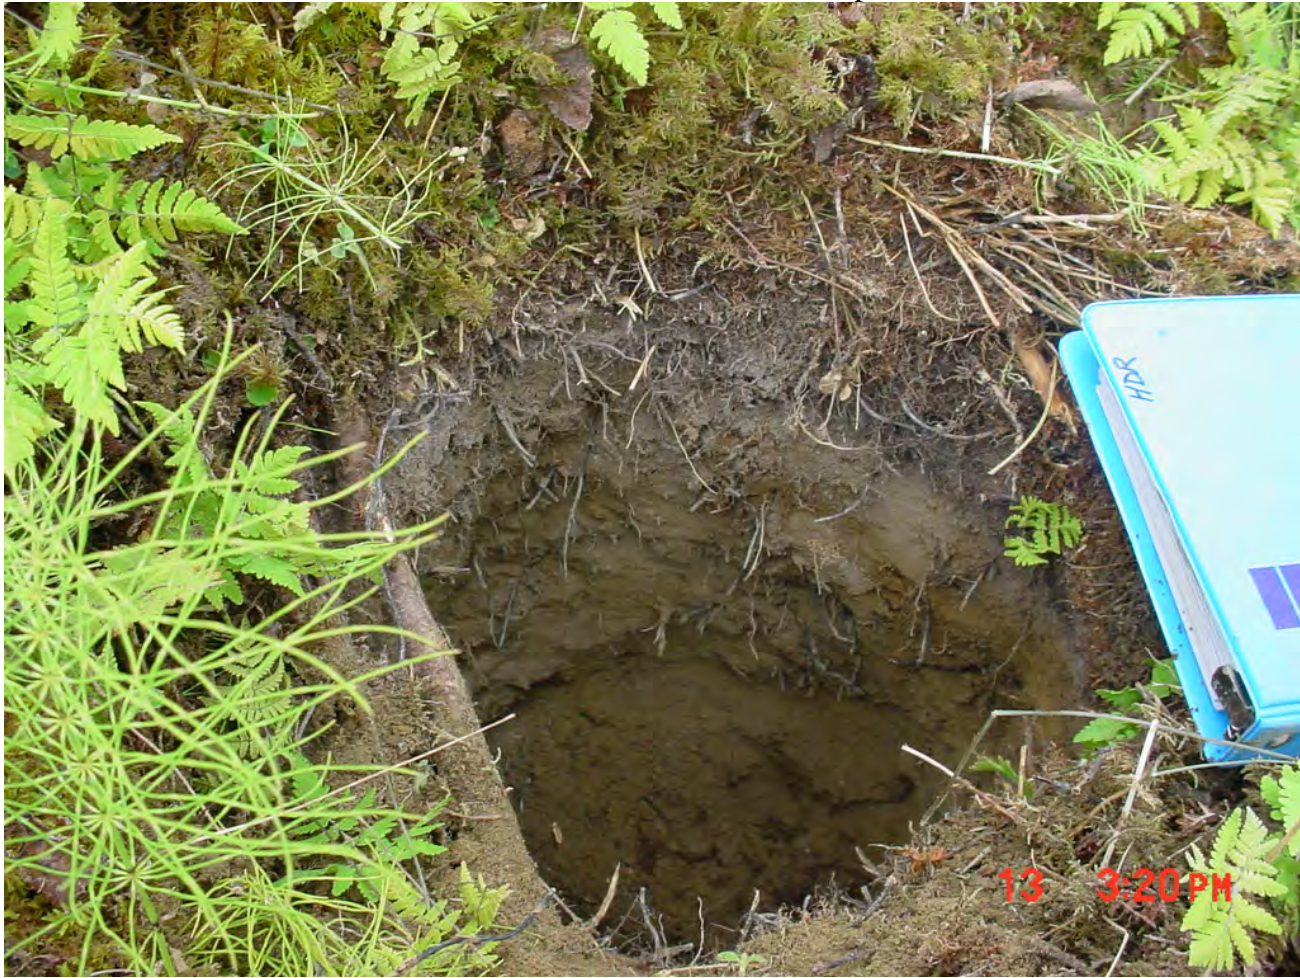
Site: Plot 9

Remarks : Lots of downed trees, Sitka spruce appear to be planted (beetle mitigation?)
* Indicates dominants using 50/20 method.

Describe Vegetation Type: Oak fern, horsetail upland with paper birch and Sitka spruce

Hydrophytic Vegetation Present?	<input type="checkbox"/> YES <input checked="" type="checkbox"/> NO	Is this Sampling Point Within a Wetland? <input type="checkbox"/> YES <input checked="" type="checkbox"/> NO
Wetland Hydrology Present?	<input type="checkbox"/> YES <input checked="" type="checkbox"/> NO	
Hydric Soils Present?	<input type="checkbox"/> YES <input checked="" type="checkbox"/> NO	
Remarks:		
GPS: Trimble plot 9 Topography: NWI Class: U HGM Type: U Photos: yes Functions:
