Fisheries Evaluation

**State of Alaska
Department of Transportation and
Public Facilities**

The Alaska Department of Transportation and Public Facilities (DOT&PF) is evaluating alternatives to improve the Sterling Highway in the Cooper Landing area. The proposed project is located between Mileposts (MP) 45 and 60 on the Sterling Highway along the Kenai River. The intention of the project is to resolve seasonal traffic congestion which results in delays to residents, travelers, and businesses. HDR Alaska, Inc. (HDR) has been contracted by DOT&PF to provide engineering and environmental support for preparation of a Supplemental Environmental Impact Statement (SEIS).

Three build alternatives, as well as the no-build alternative, are being considered in the SEIS. The three build alternatives include the Cooper Creek, G South, and Juneau Creek F Alternatives, shown on Figure 1. The three build alternatives share the same route at both the eastern and western ends of the project. For the purposes of this study, these shared areas are referred to as the “All Build” (ALL) area.

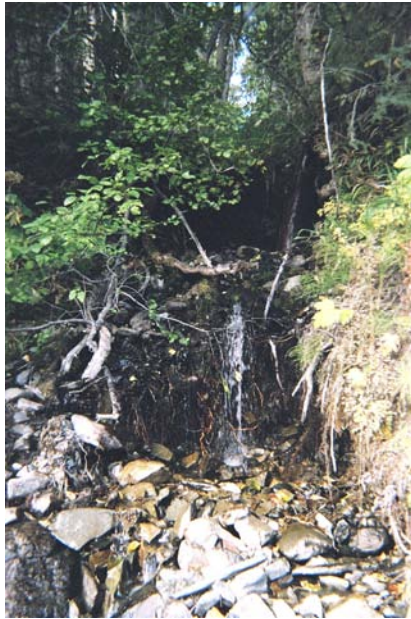
Sampling Site ALL25 (Figure 3 of 10)

This perennial stream has moderate flow, is less than 1 m in width and averages 0.20 m deep. There is a 4.5 m bedrock cascade directly upstream of culvert. This cascade appears to be a fish passage barrier. Substrate consists of large gravel in the lower reaches to smaller gravels upstream. Traps were set above the waterfall to verify resident fish population. No fish were captured.

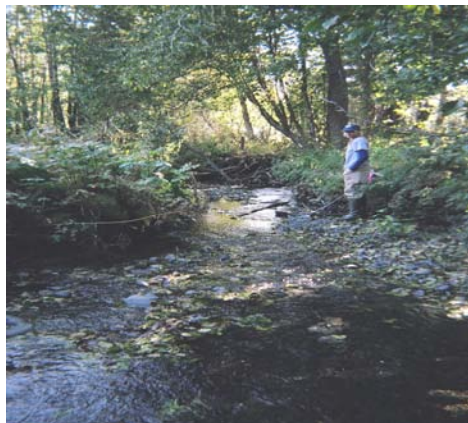
Sampling Site CCGS40 (Figure 4 of 10)

Stream has moderate flow, is 2.5 m wide, 0.25 m deep, contains predominately large gravel substrate, and is at a 5 percent gradient. Outlet of culvert is raised 0.3 m off of the streambed. Seven Dolly Varden char were captured, ranging from 50 to 149 mm in length.

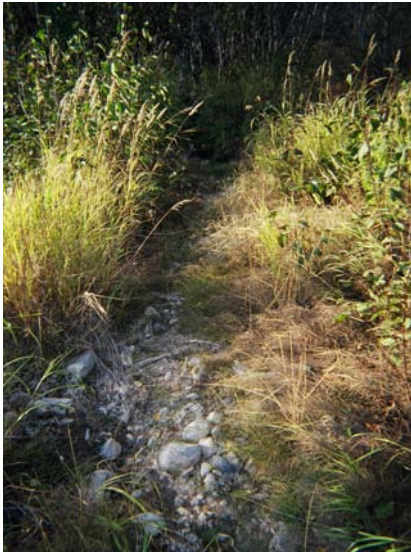
Sampling Site GS11 (Figure 5 of 10)

Channel is completely dry with no recent scour evident. A previously existing log bridge has been removed. Channel is less than 1 m wide with large and small gravel substrates and at a 2 percent gradient.
